Car Number	Chassis Number
F13-D98	AZK10-2047988

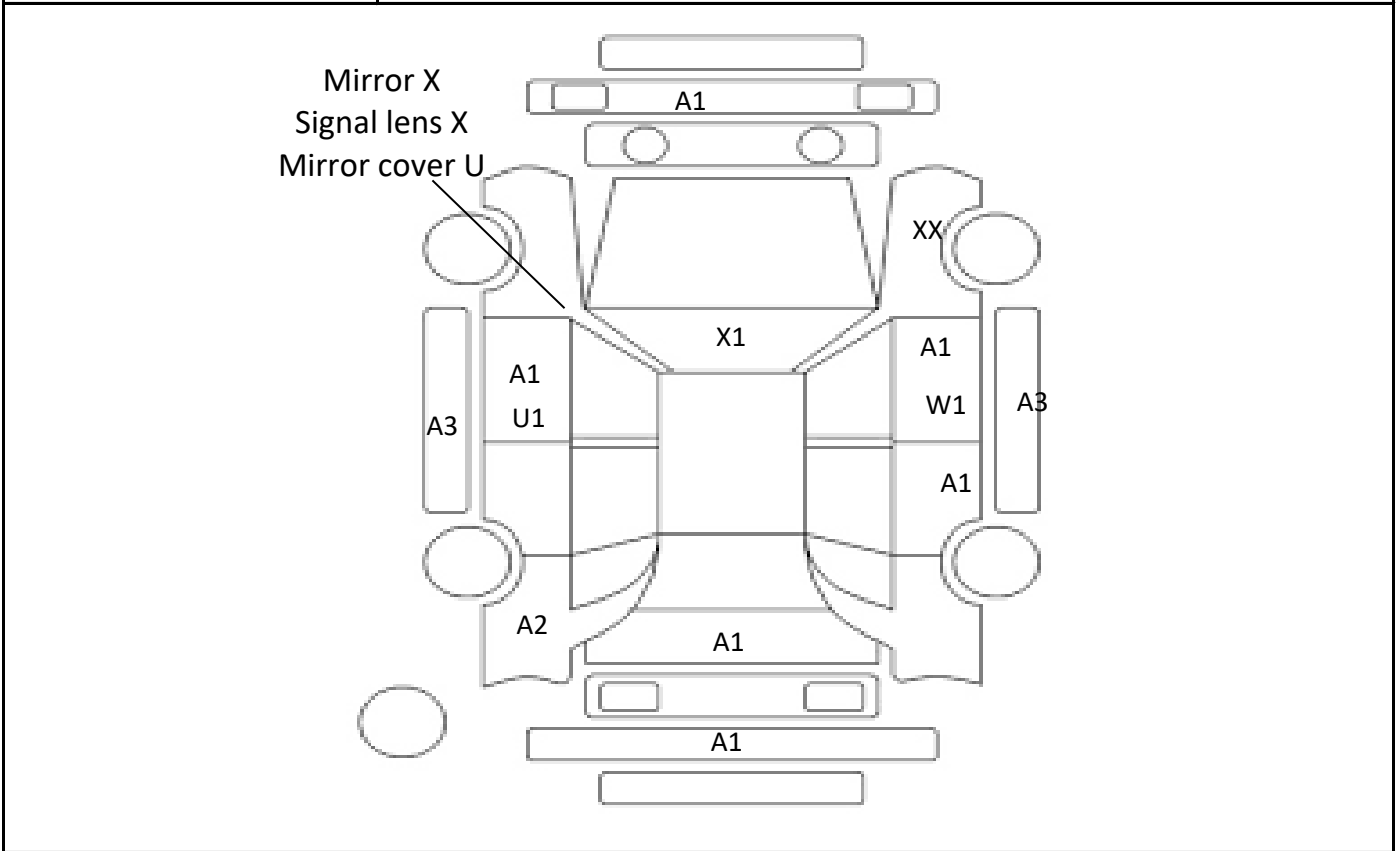
(Remark)
Left side power mirror does not work smoothly.
