Car Number

Chassis Number

G19-D48

ACA36-5025282

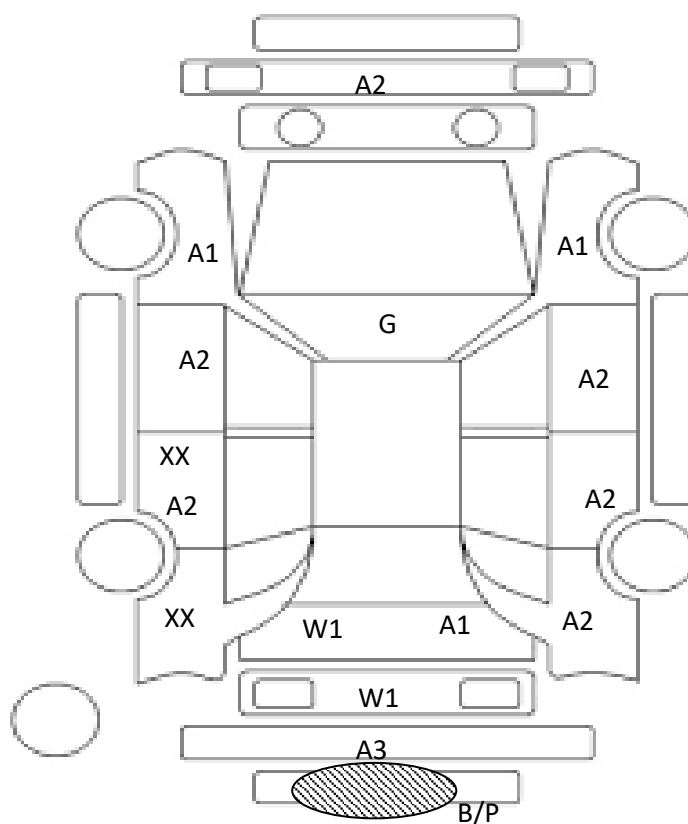
Rear Trunk floor B/P
